Lessons Learnt from Fires in Buildings

EUR 21006 EN

NEDIES PROJECT

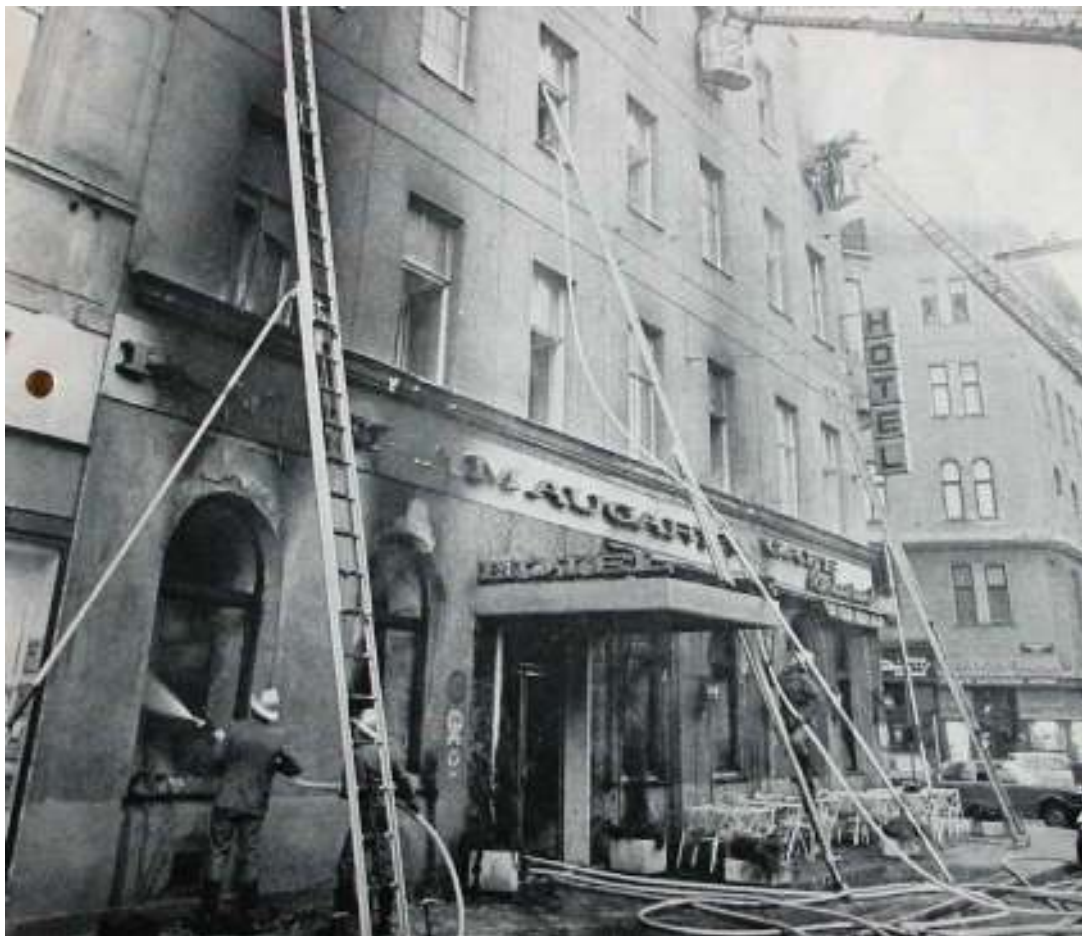
Figure 1. View from the Heinestr. Rescue operations and fire fighting still going on

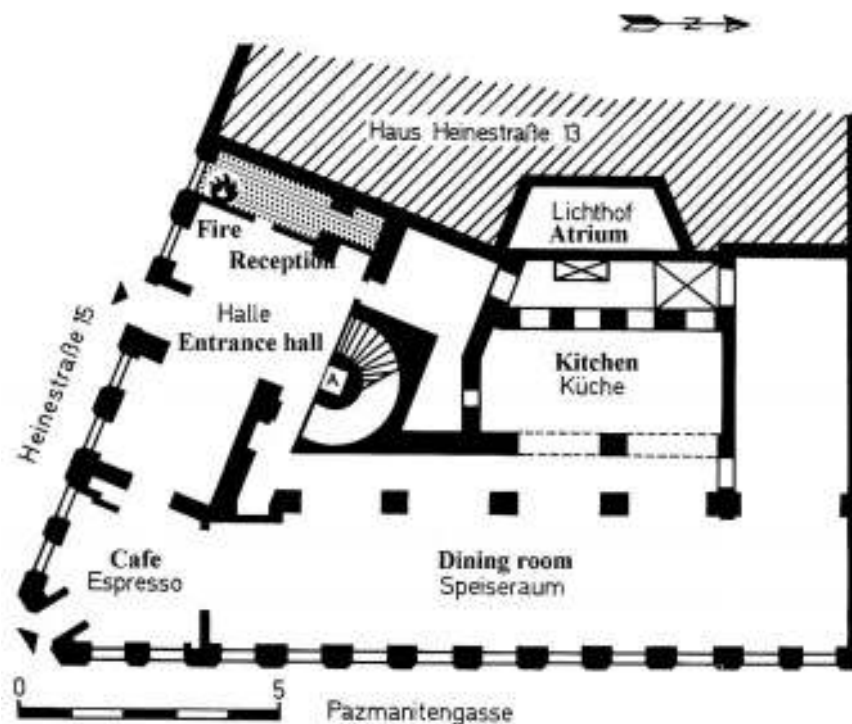
The entrance hall had an opulent furnishing with combustible materials. It led directly to the only staircase (Fig. 3). The corridors were not compartmented from the staircase. A lot of the floorings were made from combustible materials.

Figure 3. Ground floor of the hotel

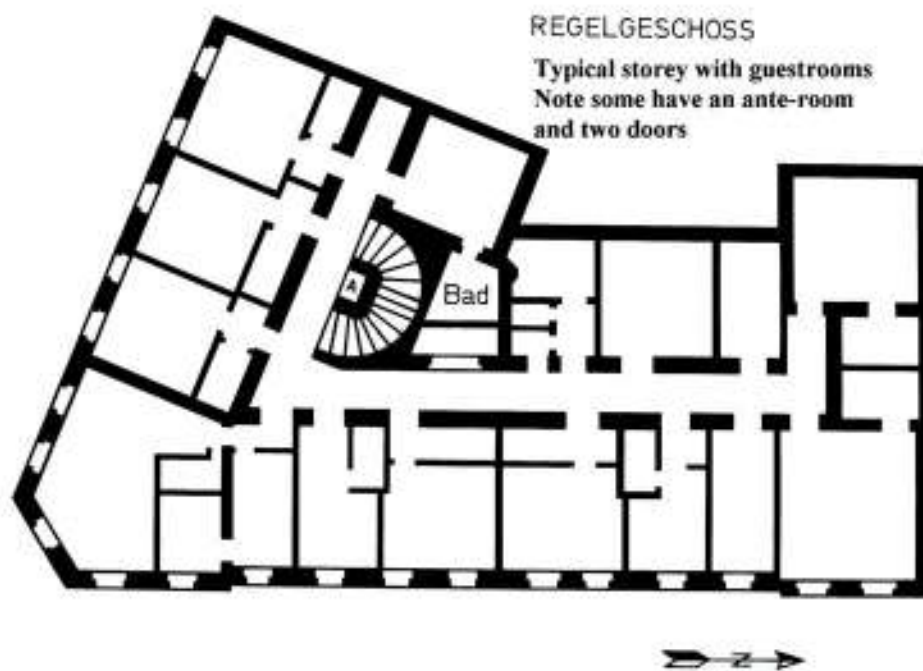
The doors to the guest rooms had neither a fire resistance nor a reduced smoke leakage. These circumstances led to an immense production of smoke, which swept through the whole building. Most victims were found in the guest rooms, which had only one door between the corridor and the sleeping room (Fig. 4).

Figure 4. Typical storey with guestrooms

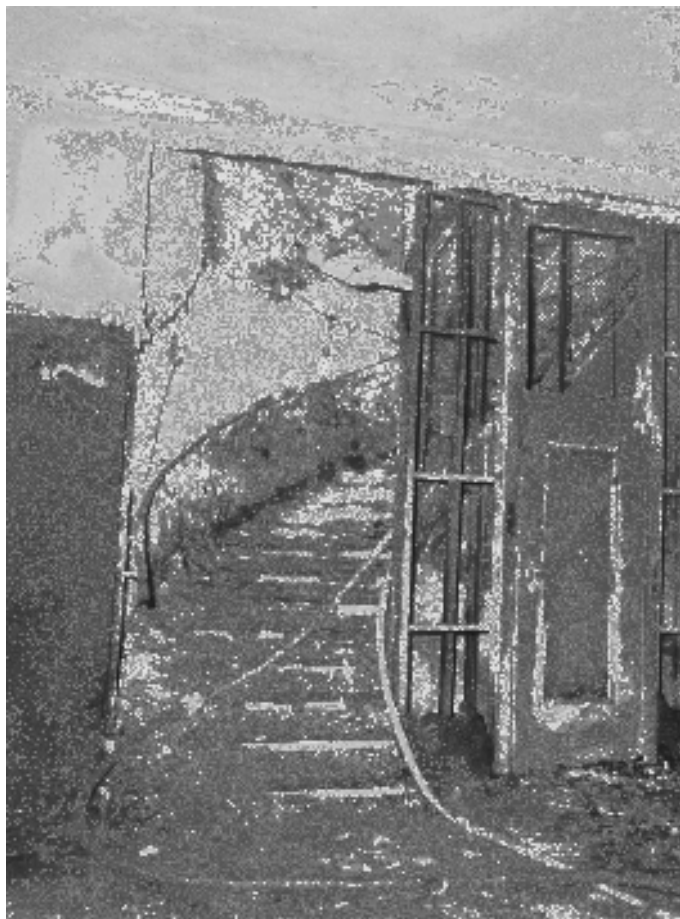
- Combustible floorings and furnishing.
- No separation between entrance hall, staircase and corridors (see Fig. 5).
- No fire detection system.
- No alarm system.
- No staff present, no staff training.

Figure 5. View from the entrance hall to the staircase

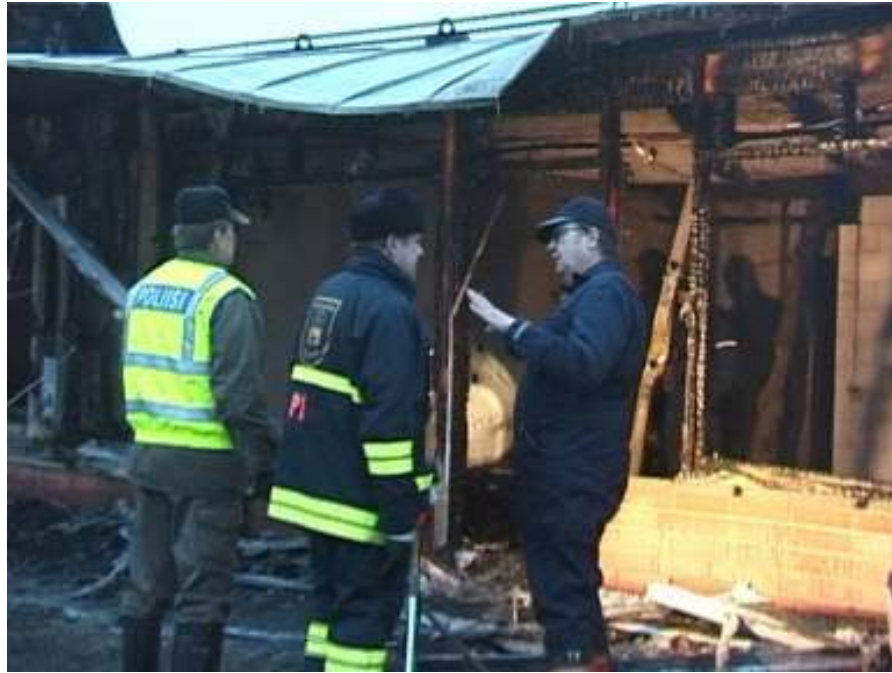
The building was completely destroyed. Fire spread to the attic of the entire building and to the corridors and halls as well as to some of the flats. The rest of the flats suffered water and smoke damage of varying degrees (Fig. 3).

Figure 3. Fire investigators at the ruins of the burnt down service house

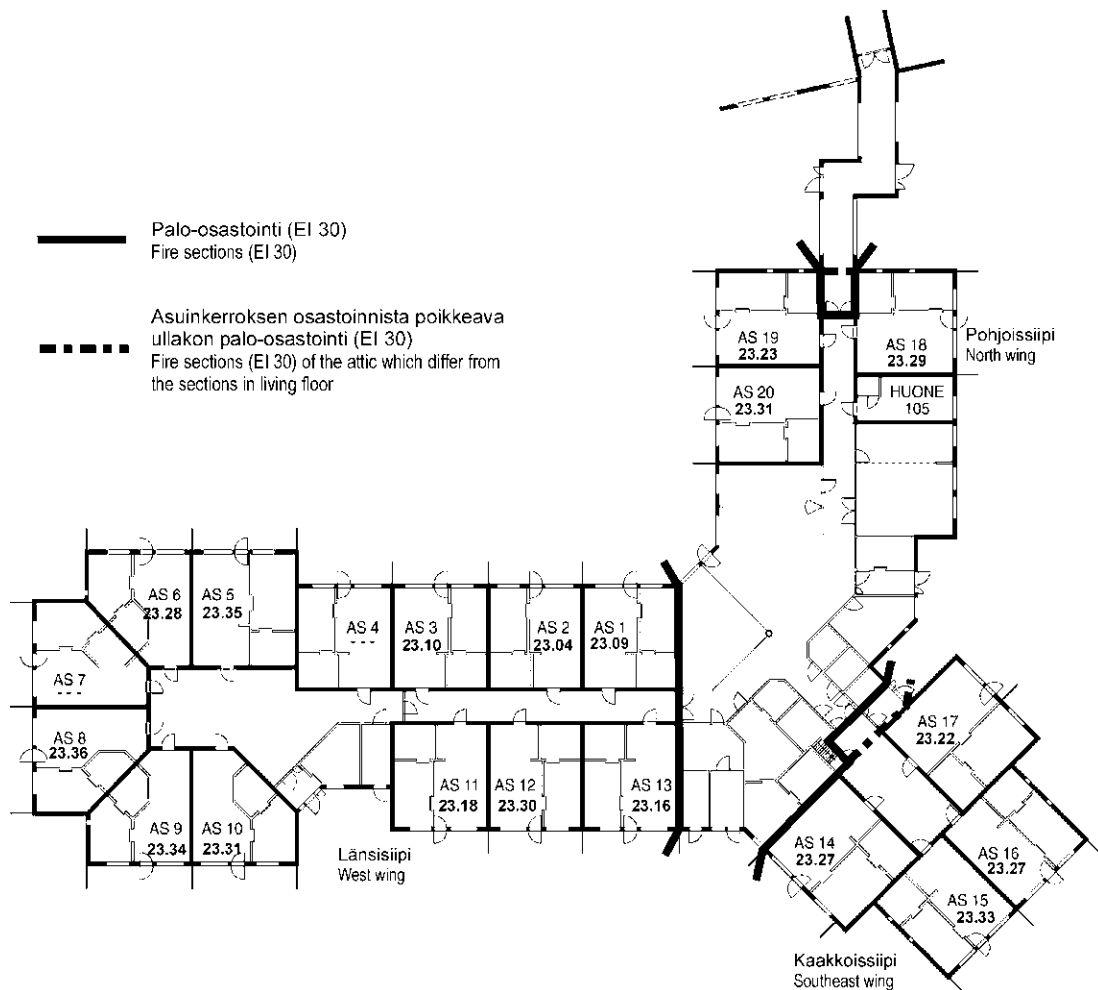
Each flat had one or two smoke alarms that were connected to the security phone system. The building was not provided with automatic fire detection and alarm system nor was it protected by automatic sprinklers. There was no alarm system to notify occupants of an emergency nor was there any centralised means to report a fire other than using the telephone. The delay in alerting the fire brigade had great significance.

Figure 4. General layout of the service house. Fire compartments plus activation times of smoke alarms in the flats are marked in the picture

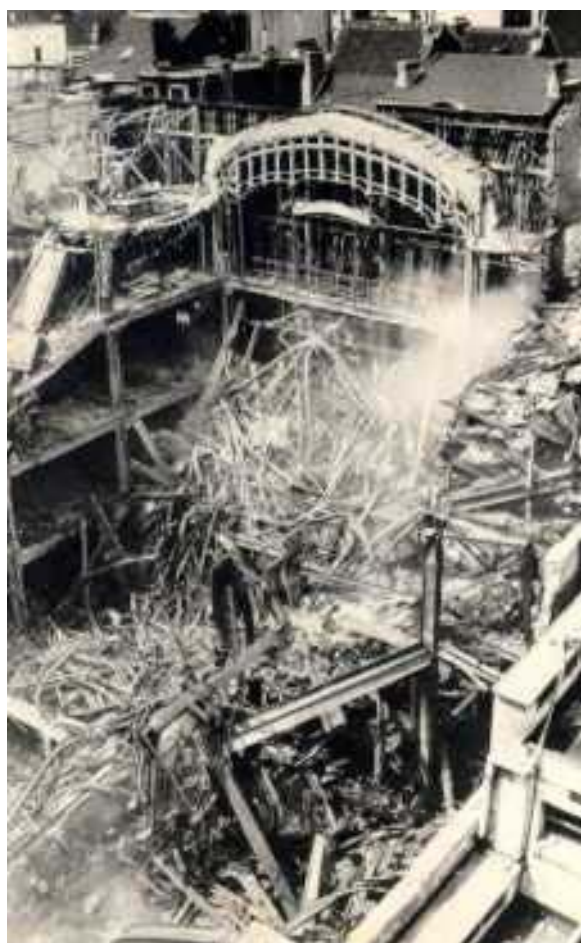
The total damages amounted to about 1.5 billion BEF (or about € 40 million), which in real terms corresponds to an amount of about € 100 million (Fig. 2).

Figure 2. View of the building after the fire

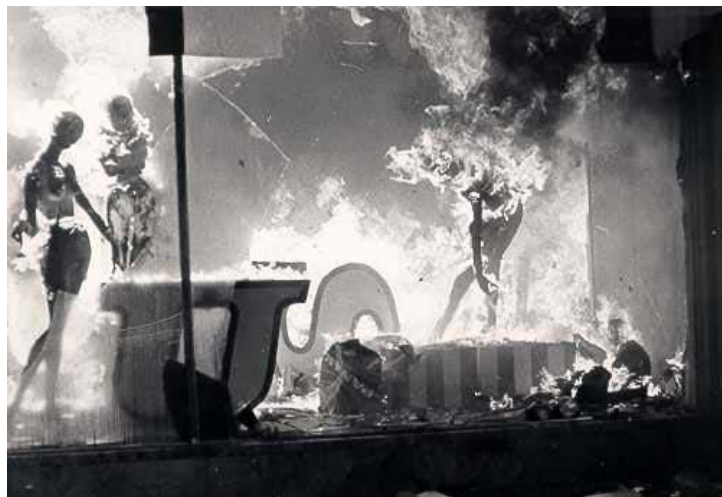
- No compartmentalisation. The storerooms, where lots of flammable materials were stored, were not separated from the shopping section.
- The monumental staircase and the atrium created a chimney effect, as a result of which the smoke and fire had free play.
- The store did not have an automatic fire extinguishing system (sprinkler).
- The internal (and also external) fire alarm call came too late, which had fatal consequences.
- As the lighting system cut out very quickly, many people were unable to find the emergency exits.
- The front windows were closed off (aluminium panelling).
- The stability of the building in the event of a fire was deplorable; many metal girders were not protected.
- A fire detection system had been installed only in the display windows and the roof.
- The store was full of highly flammable material (Fig. 4).

Figure 4. Flammable material at a display window

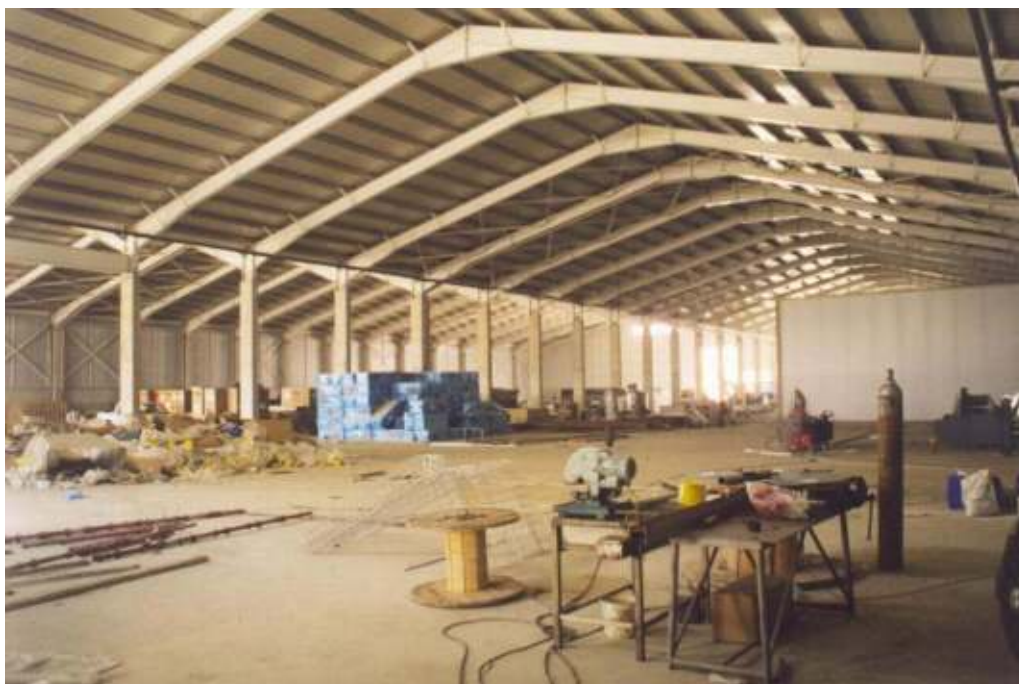
Figure 1. A view of the factory from inside. At the back it is visible a compartmentation which does not extent all the way to the roof!

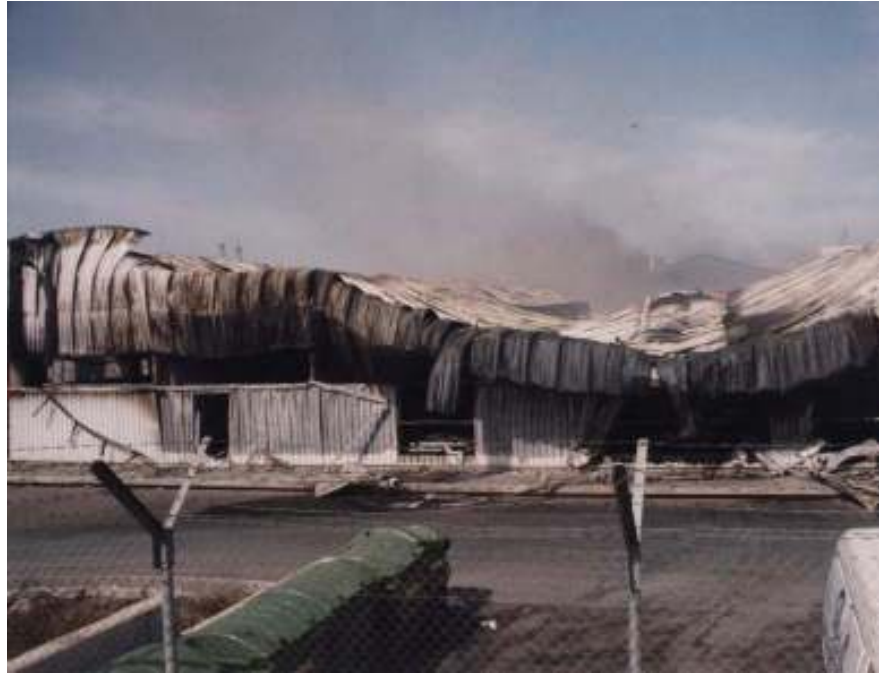
Figure 2. P.D.I. factory after the fire. Partial collapse

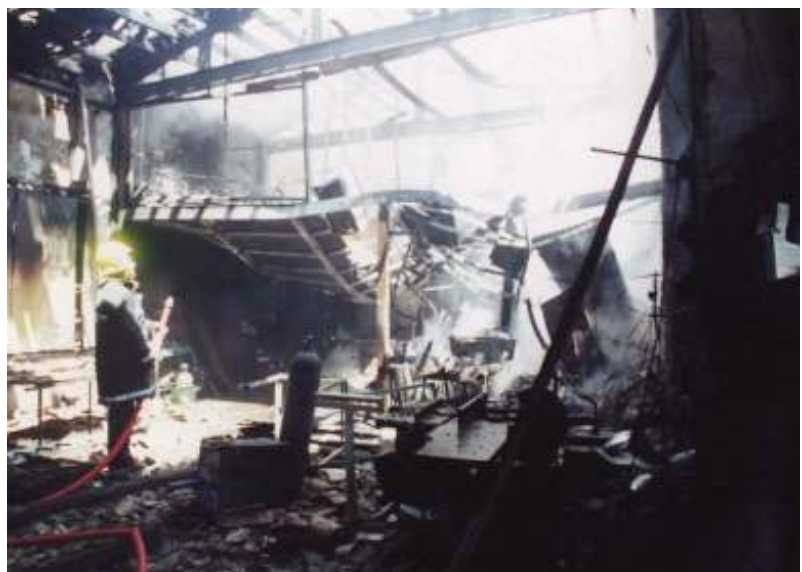
Figure 3. View of the factory after the fire. Next to the fire fighter the argon welding machine

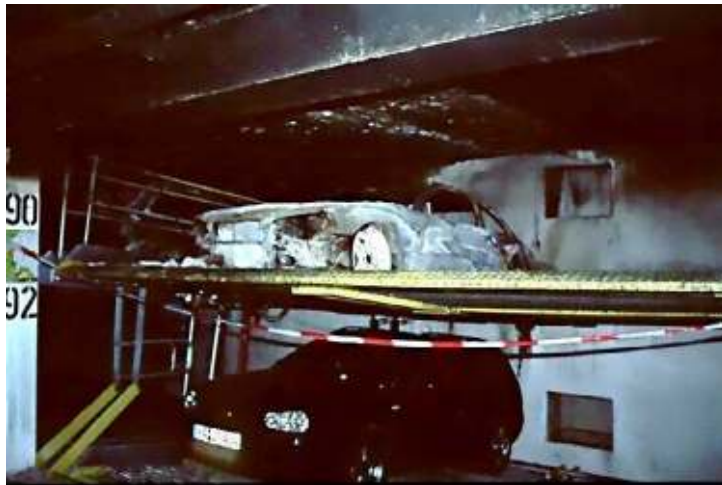
A car fire started on the upper parking space No. 90. The reason of ignition could not be determined (Fig. 2 and 3). The residents realised the smell of smoke at 00.27 hrs.

Figure 2. The parking space, where the fire started

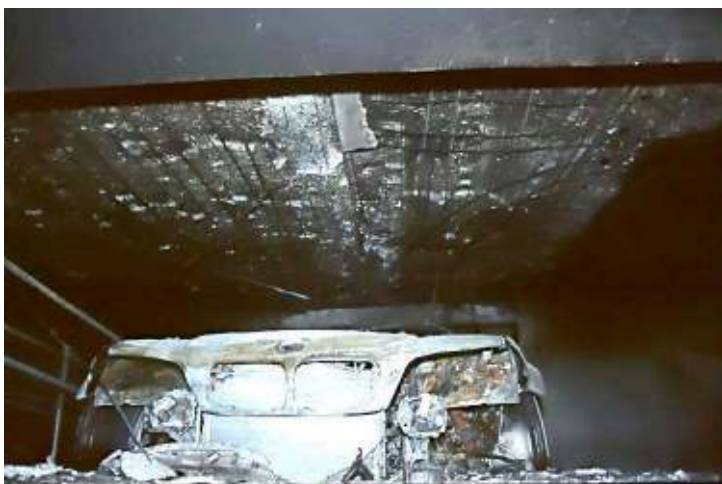
Figure 3. The burning source, above the chipping concrete

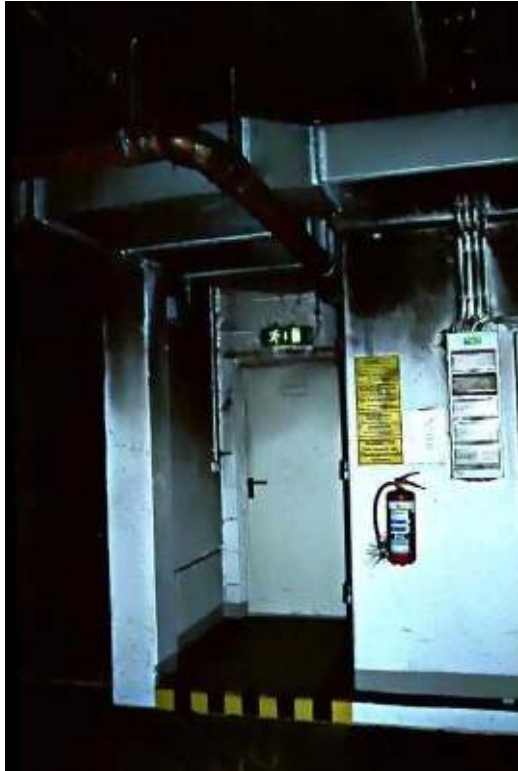
Figure 5. Firedoor opposite to the burning source. The illuminated Emergency sign still works (the photograph was taken the day after the incident). There is a good view of the damage by smoke

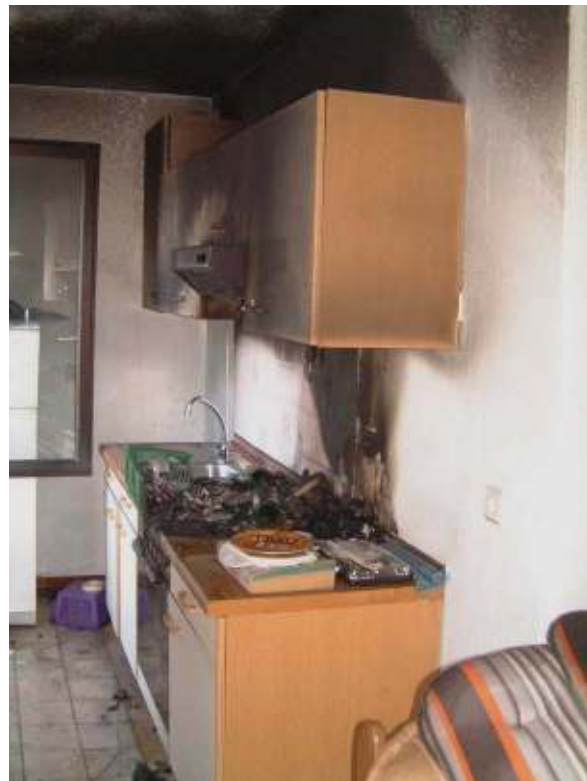
The reason of ignition was a plastic tool box laid on a electric stove. The whole apartment was cut of electricity for a long time, because nobody lived in it. The new lodger had this information and did not take account of the switches of the stove (Fig. 9). During his absence the power supply was put on from the power service. The stove switch was on and the plate set the plastic tool box in fire.

Figure 8. Little damage in the kitchen

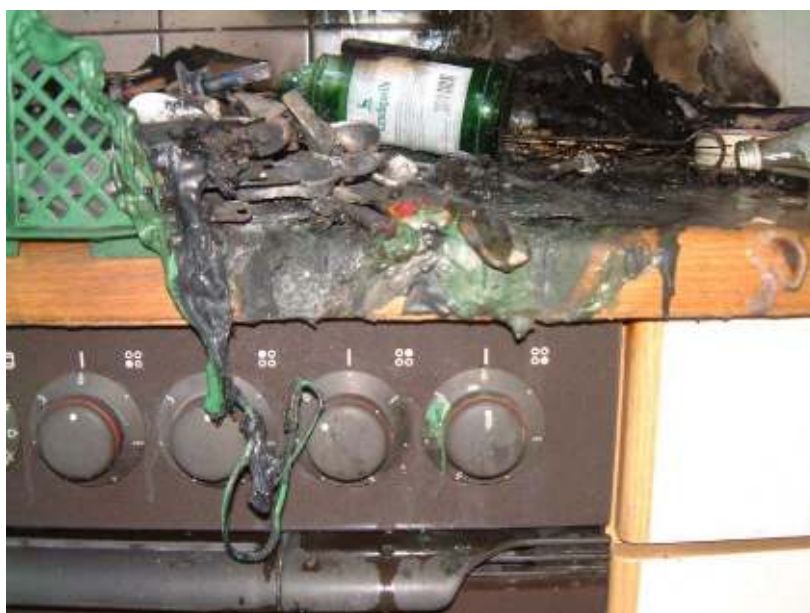
Figure 9. Recognise the switch...

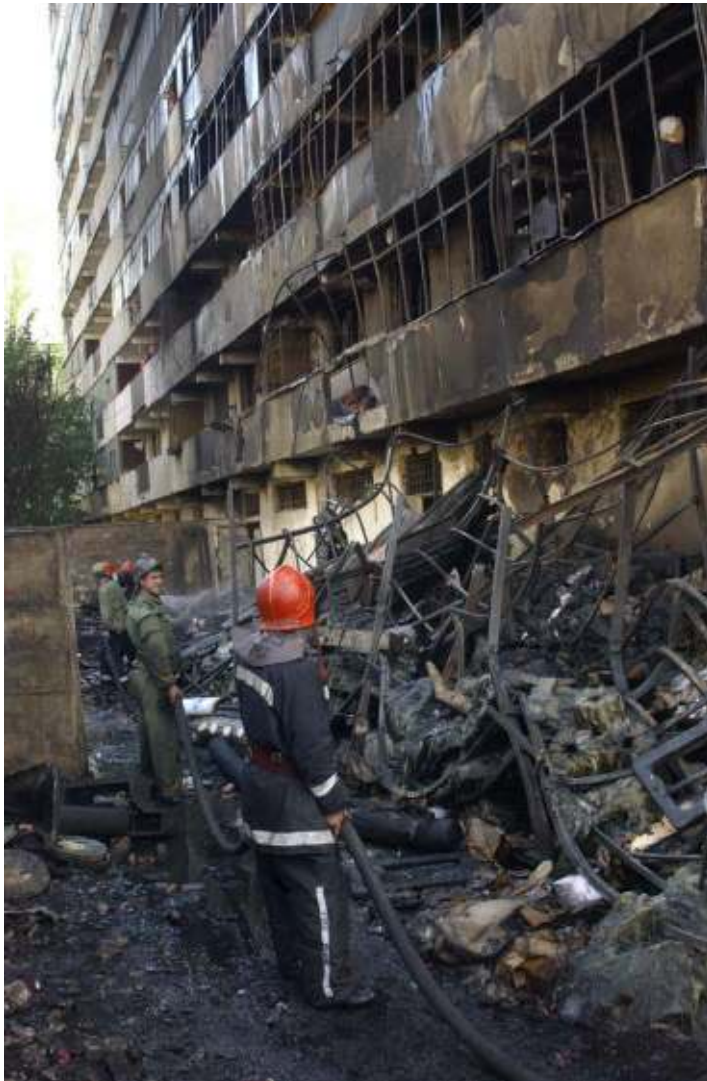
Figure 2. Detail of the illegal metallic cover of the commercial space of the firm responsible for the disaster

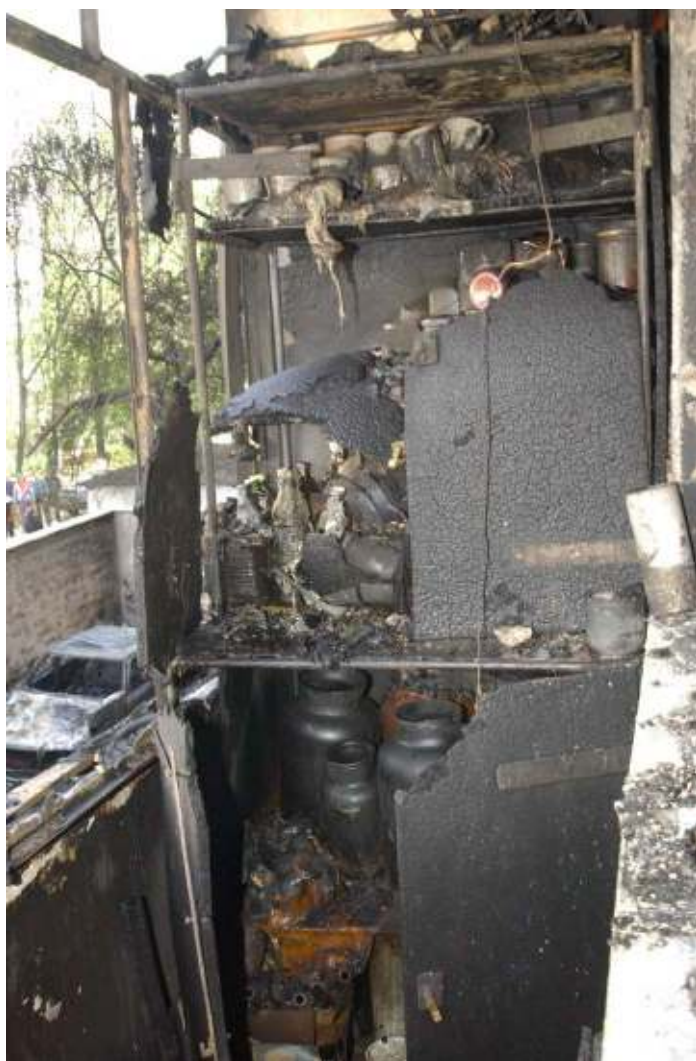
Figure 5. Large quantities of combustible materials are usually stored in the houses which favour the fire propagation (example in the affected 10-storey block from Drumul Taberei area)

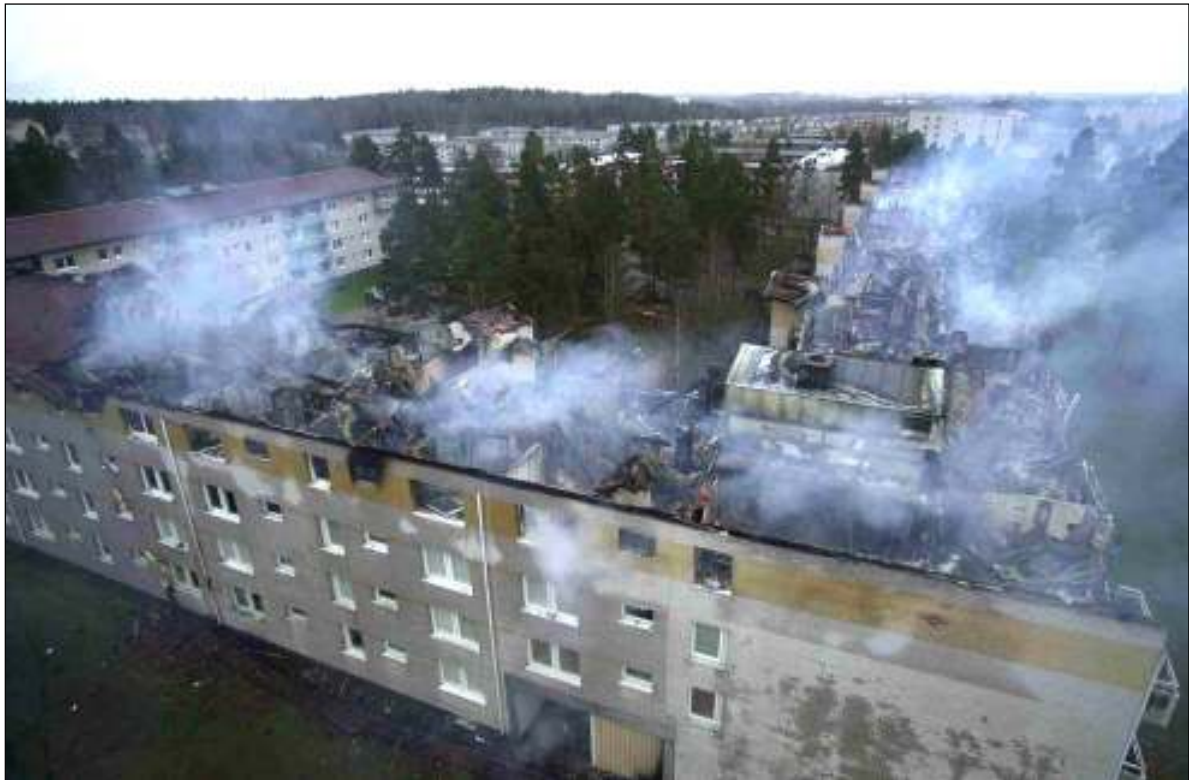
Figure 1. View of the building after the fire

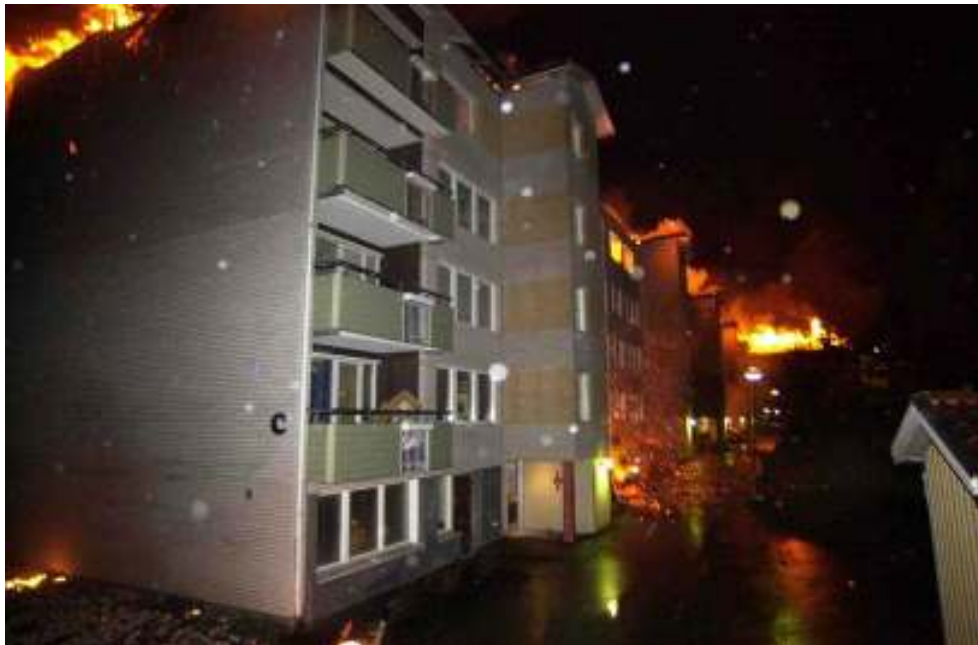
Figure 5. Brick wall falling in the space in front of the building (at the south end)

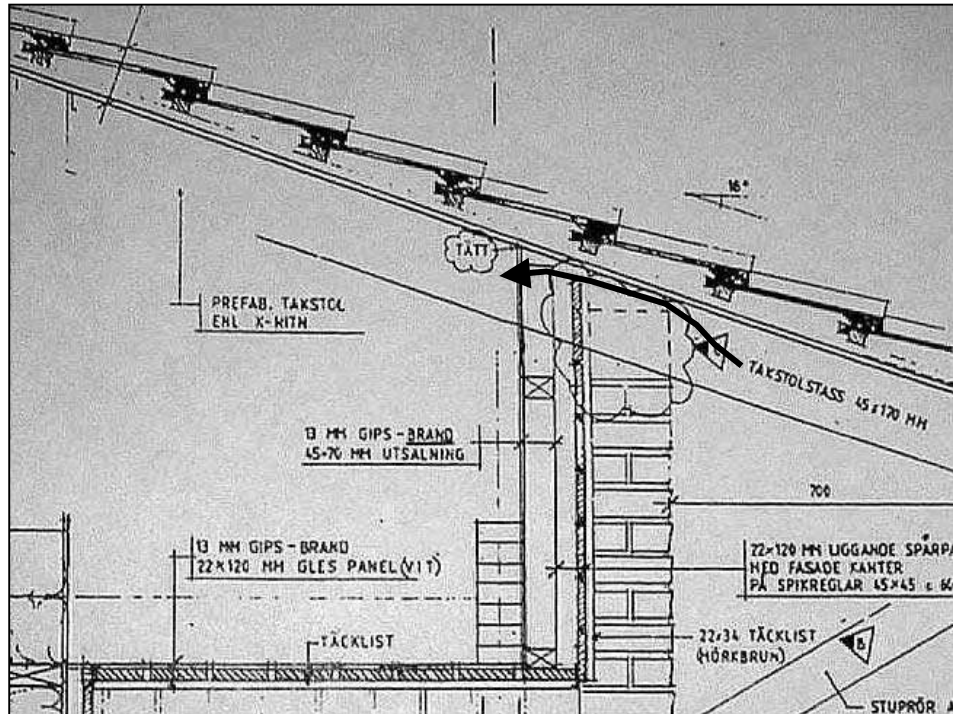
The rapid spread of fire inside the attic was due to the use of a light wooden truss roof construction that did not meet the intended standards set in the building code.

Figure 8. The construction where the wall meets the roof, opening at arrow

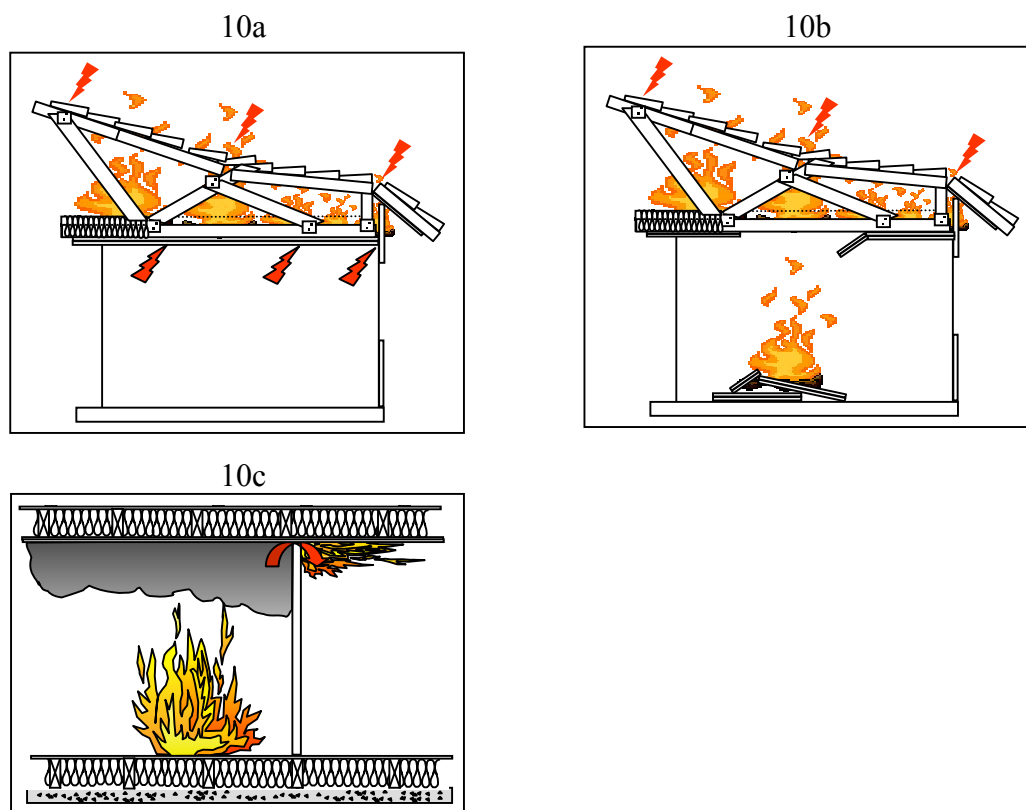
Figure 10. Fire spread through different weaknesses in the construction
